# Inspection Report

123 Main South Street  
Plant City, FL 33566

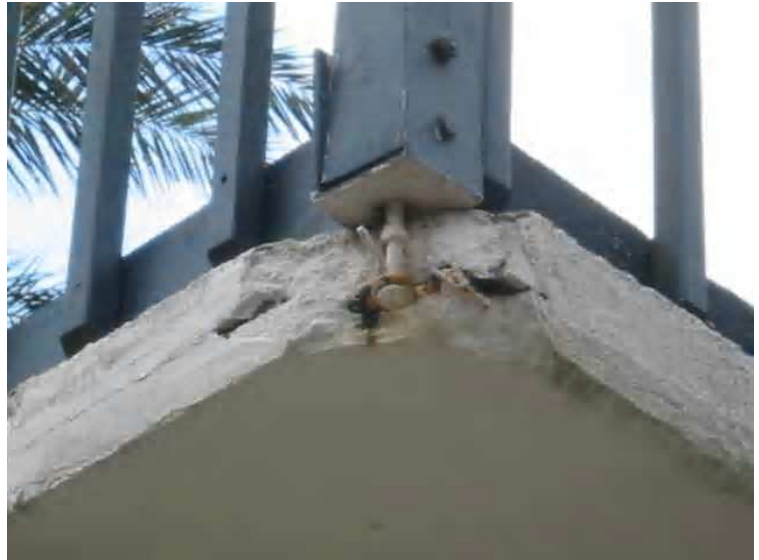
Structure - moisture intrusion has affected the ferrous metal fastenings of the safety railing, a metal retaining bolt has expanded due to rust, see full report.

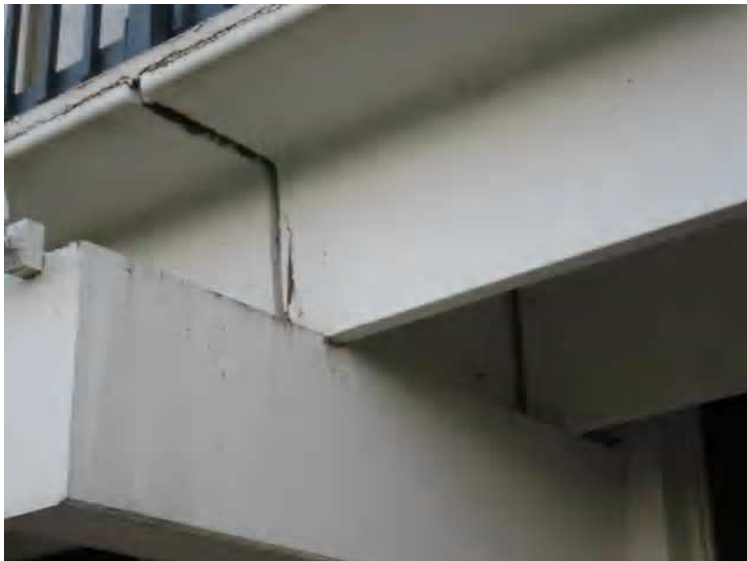
Structure - The deck area on the eastern end of Building B [BD2 diagram 1]. Damage to both portions of the bearing surface has led to expansion of the structural steel, resulting in spalling of both the grade beam and the deck support.

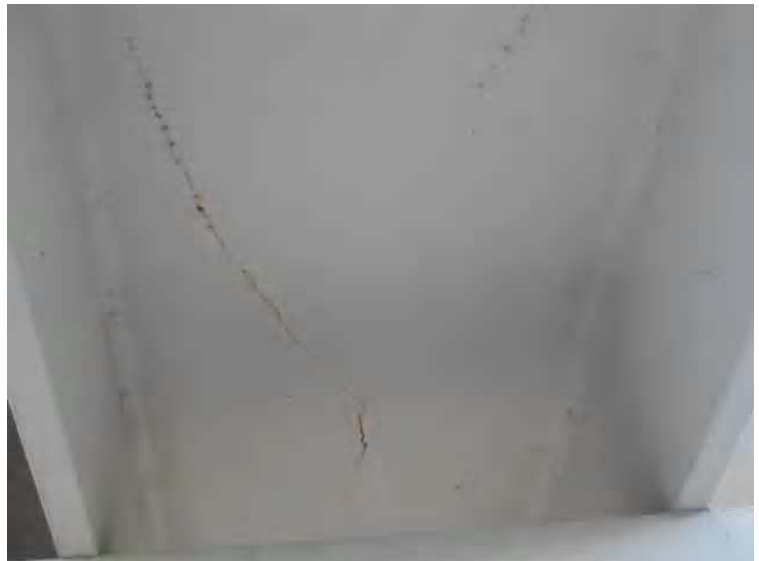
Structure - Deck depicted immediately above [BD2 on diagram 1] the line that can be seen on the underside of the deck is of a crack or fissure presumably running right through the deck, as it is showing signs of moisture intrusion, leaving rust stains along the crack.

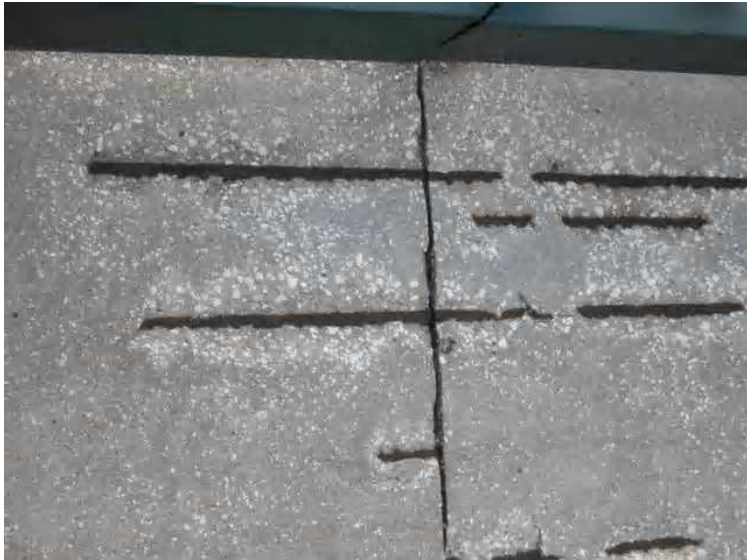
Structure - Building. B. [BD3 on diagram 1] the structural steel ties between structural elements were installed to closely to the surface, erosion and wear have left these exposed to the elements. This again is a structural problem, as the steel serves to tie the elements together.

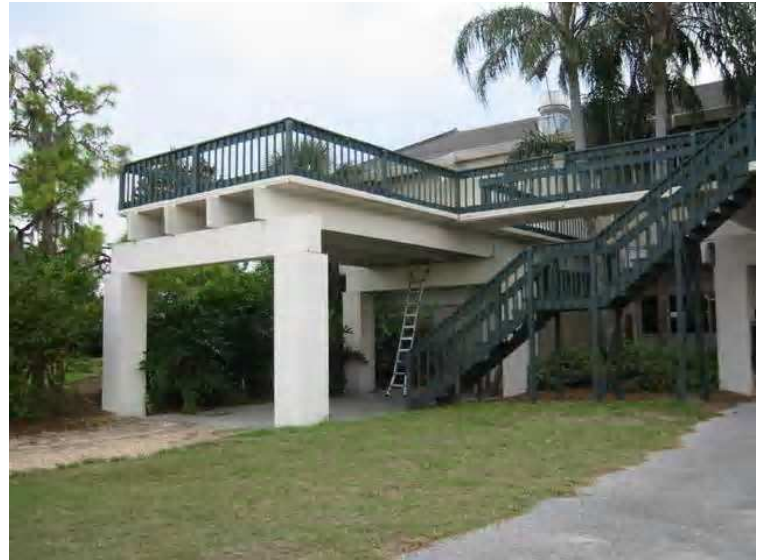
Structure - [BD4 diagram 1] it is this deck that poses the largest structural problem at this time,. There is considerable damage due to corrosion and spalling around the bearing surfaces. It also appears that there is possibly some rotation of the grade beam supporting the end of this deck.

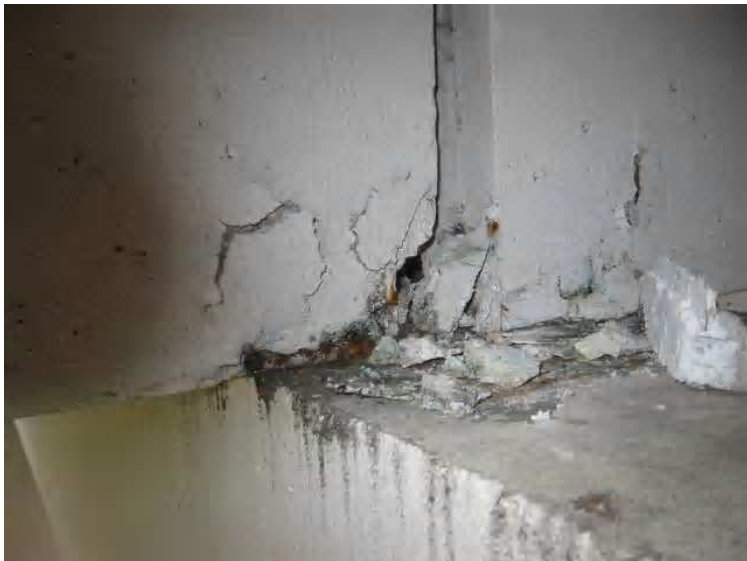
Structure - Failing deck bearing to grade beam connection [BD4 diagram 1] this damage is typical of all of the bearing connectors that should be supporting the live and dead loads associated with this structure.

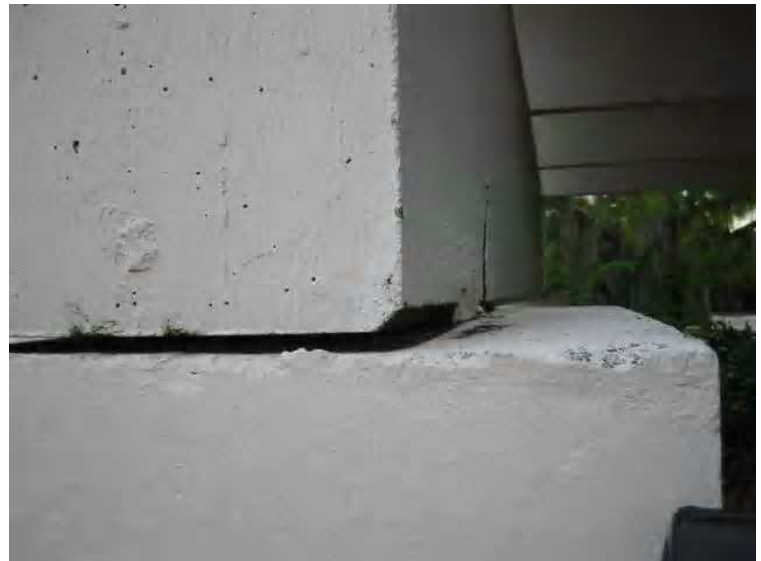
Structure - The picture appears to show signs of rotation of the grade beam supporting the extreme edge of the second-story deck [BD4 on diagram 1]

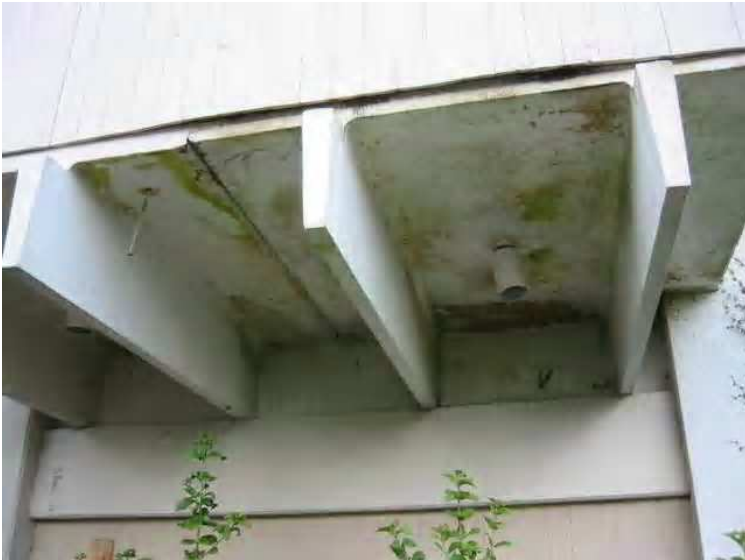
Structure - Cantilevered section of the second-floor kitchen in Building B. Condensation from the refrigeration units has been allowed to permeate this overhang resulting in significant rusting of the structural embedded steel, damage to the walls framing and siding and considerable mold, and bacterial growth on the underside of the floor structure.

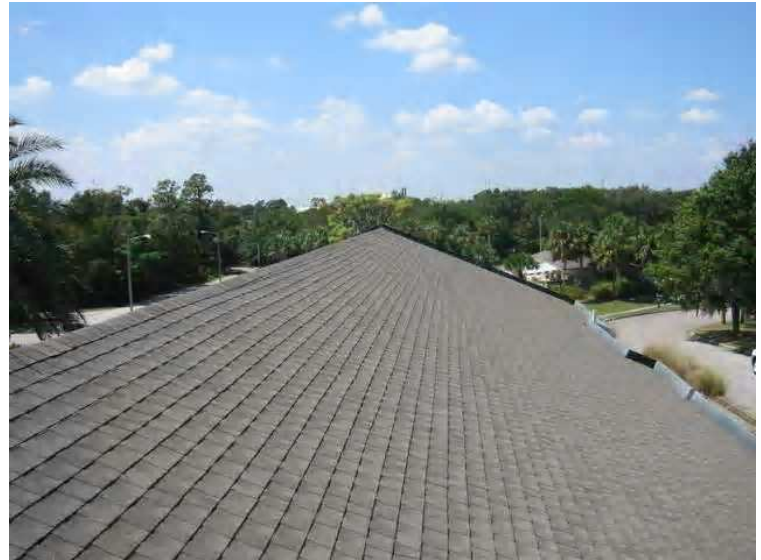
Roof - This picture shows the roof covering over Building A. [see Diagram 1] the coverings and sheathing show signs of settlement on the Western end of the structure. Possibly due to rot as noted in the exposed ends of the rafter framing.

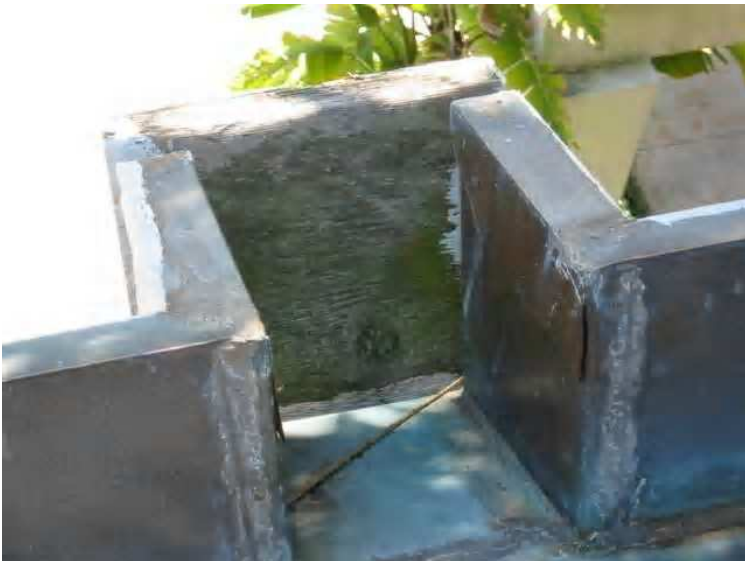
Roof - Copper scupper detail on the south side of building A. Many areas of the roof the flashings were disturbed by recovering the roof and the joints were re-adhered using roofing cement rather than being re-soldered, see full report.

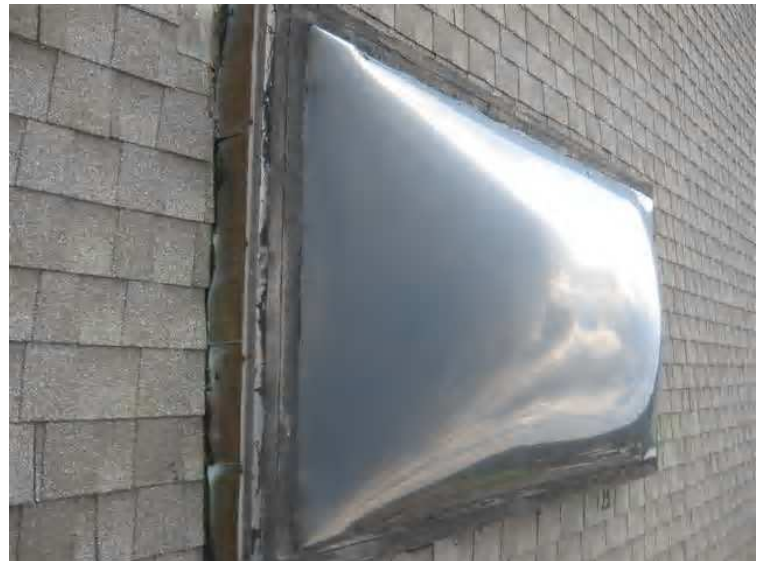
Roof - Both of the roofing skylights [Building B] have been extensively patched with roofing cement, presumably due to previous leakage.

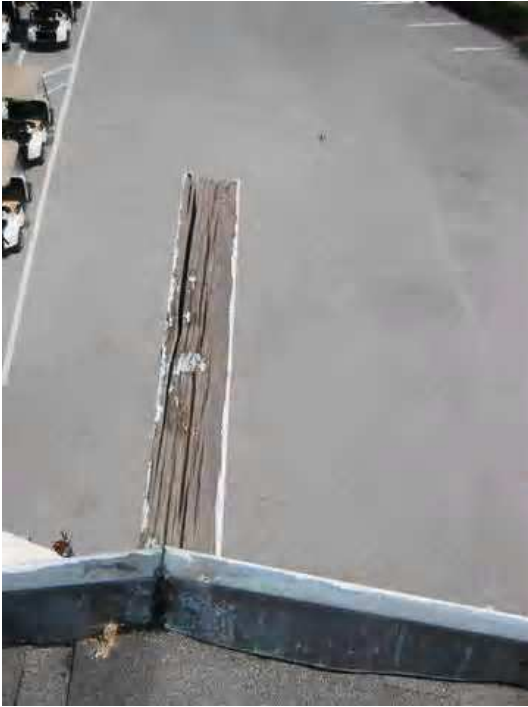
Roof - Projection area of the ridge beam on the eastern end of Building A. this damage is typical of all the exposed timbers projecting past the gable ends. The damage has been brought about by lack of maintenance [particularly lack of painting and caulking on a regular basis.

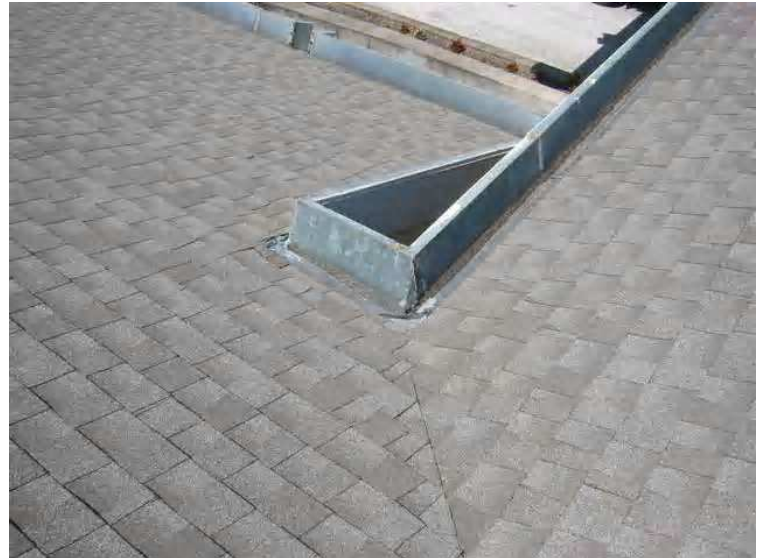
Roof - This image shows the flashing detail at the connection of the entryway roof to building A. it appears that all of these type interfaces between the roofing junctions have failed allowing moisture entry into the roofing fascias, soffits and sheathing.

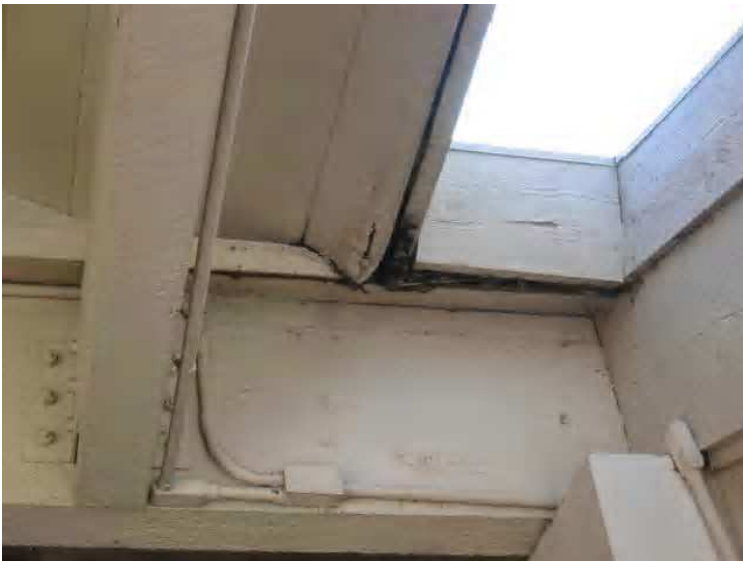
Roof - This picture is of the soffit and fascia area under the connection of the breezeway and building A. extensive rot and decay is clearly visible. And we recommend further evaluation of these areas by a licensed roofing contractor at the very minimum.

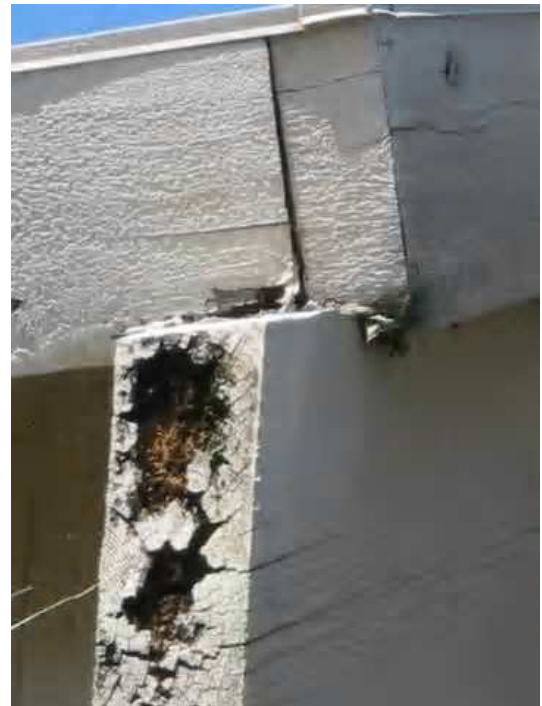
Roof - Leaking through the flashings resulted in rot to the Fascia, soffits and the exposed end of the rafter tail, see full report.

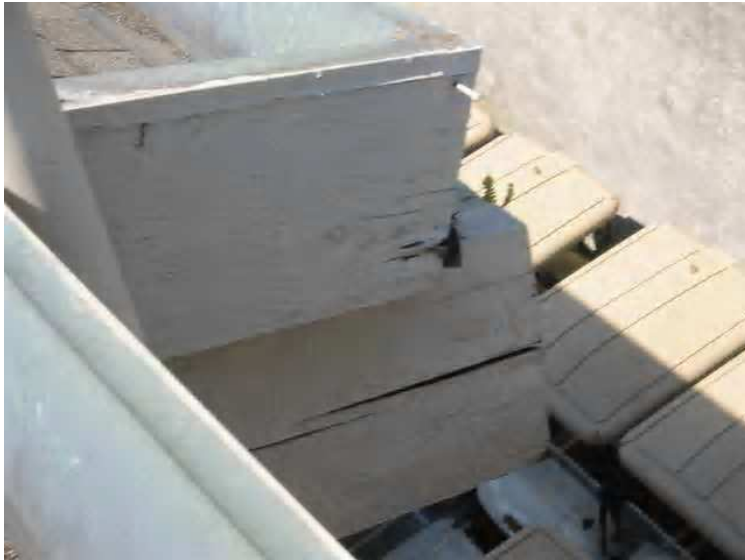
Roof - This image [taken on the south side of building B.] again shows damage to the fascia, soffit and roof rafter, and requires further evaluation.

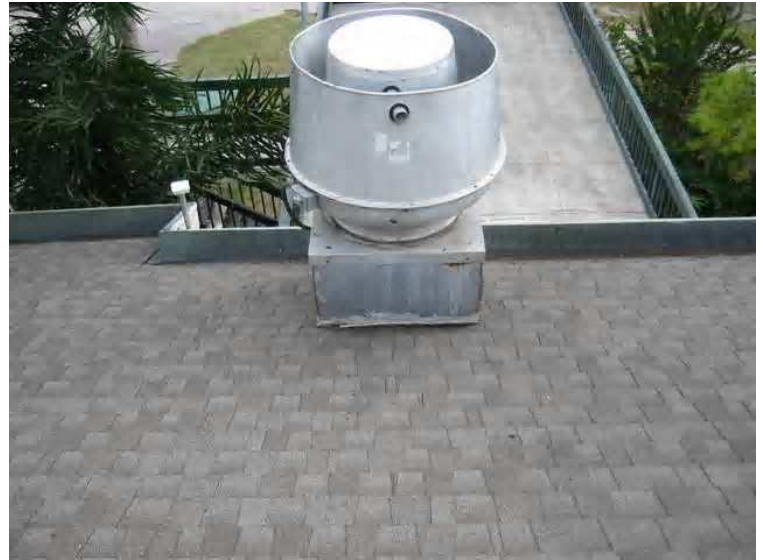
Roof - Pictured to the right is the vent for the kitchen extractor fans on the south west side of building B. This vent has defective flashings allowing moisture to enter the building [see interiors report]

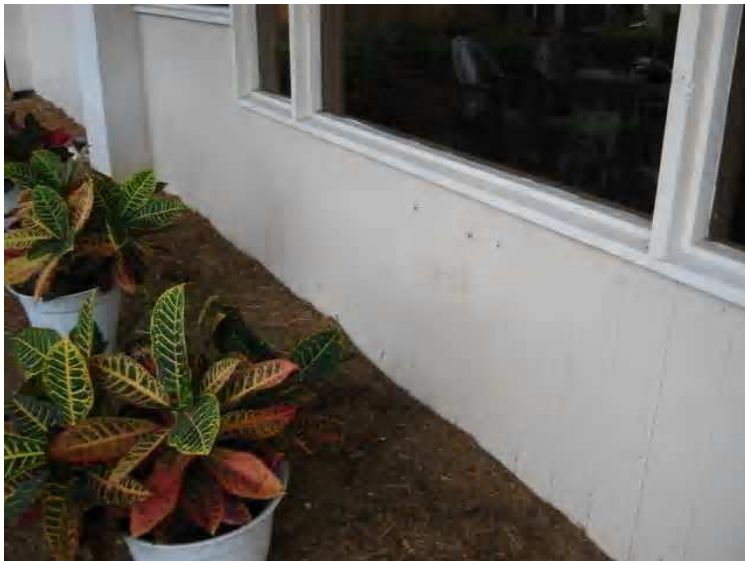
This image [typical of all areas] is on the north east side of building B. here the grade level is in contact with the siding leading to elevated moisture levels and rot damage [all wood siding materials should be a min of 6 inches above grade]

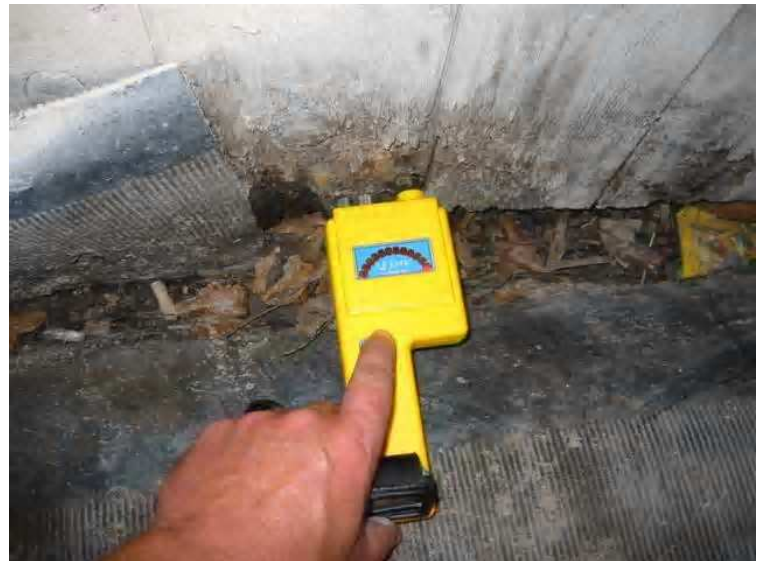
In this image [taken on the south west corner of building A.] the moisture meter is showing readings exceeding 30%, moisture levels this high cause the siding materials to rot.

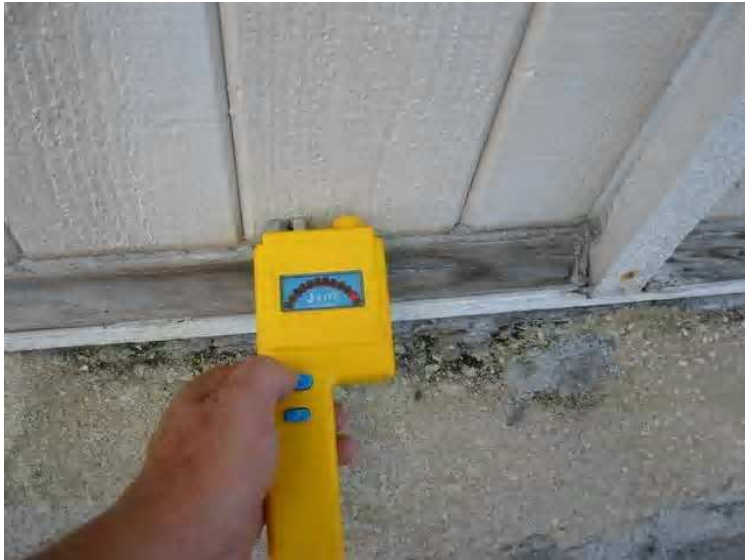
This picture is again showing moisture levels of 30% this image was taken on the second floor siding adjacent to the deck structure outside of the club offices on building A. [see AD1 on diagram 1].

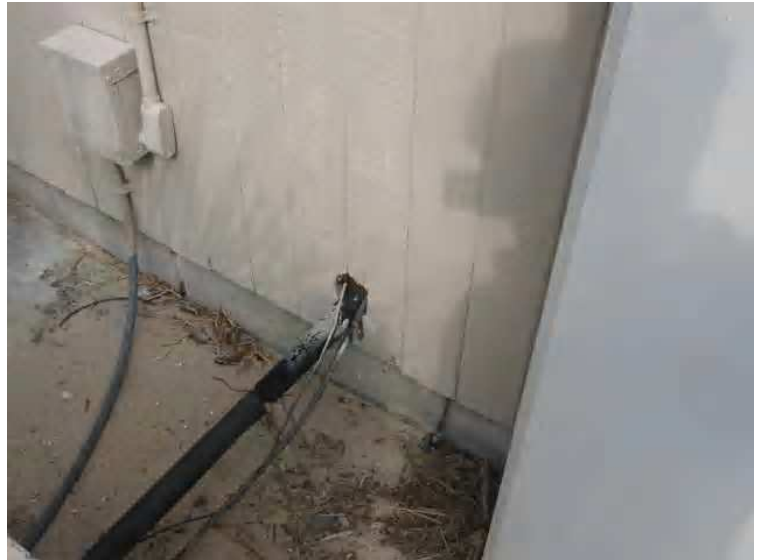
Here we are looking at unsealed openings into the structure [this picture from the AC compressor area on the east side of building B] any unsealed entry into the structure will result in moisture intrusion and possible insect damage.

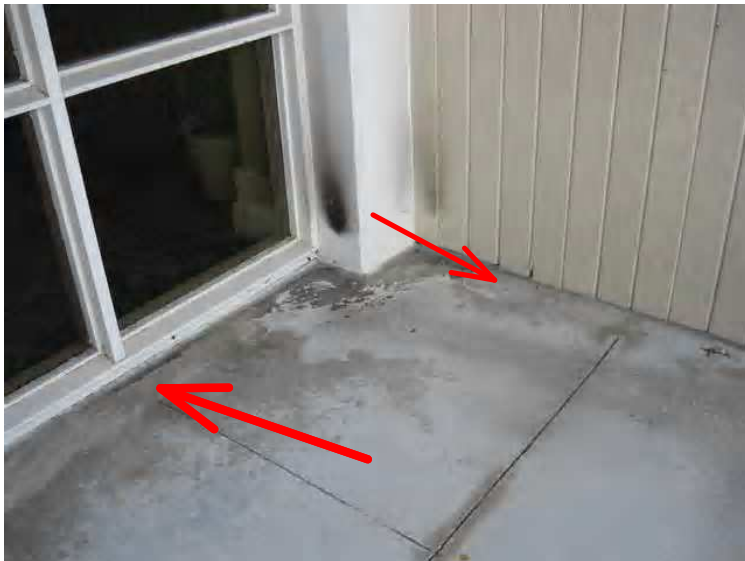
Repairs to stop moisture entry due to the deck having insufficient slope to direct water away from the structure. In this case a concrete apron was poured but was not effective as can be seen from the considerable amount of silicon sealants applied in this area.

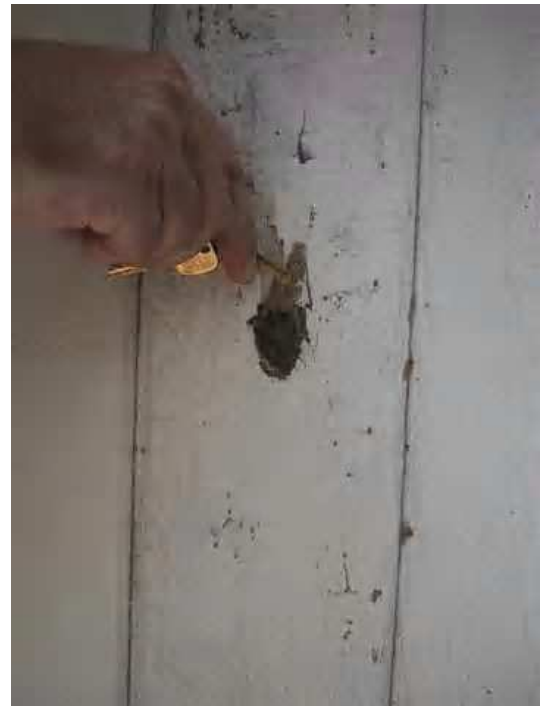
South side of building A. adjacent to the entryway to the ladies locker room shows signs of termite activity.

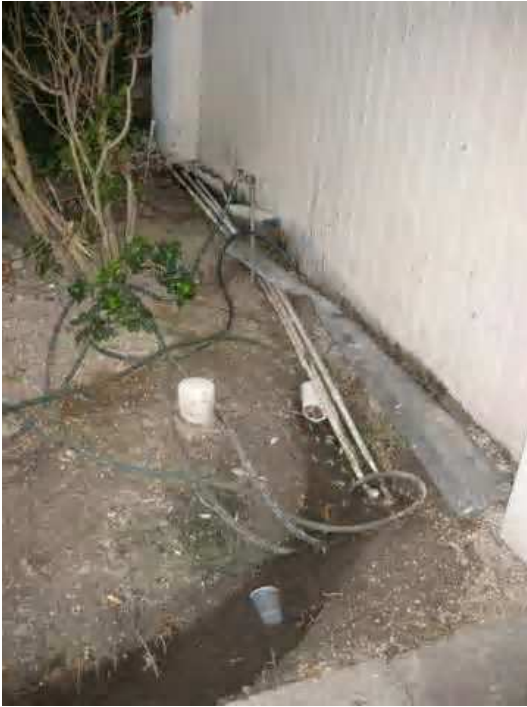
South west side of building B. and shows damaged condensation lines. Due to inadequate drainage all of this condensate is being retained directly against the structure's siding and sill plate in this area.

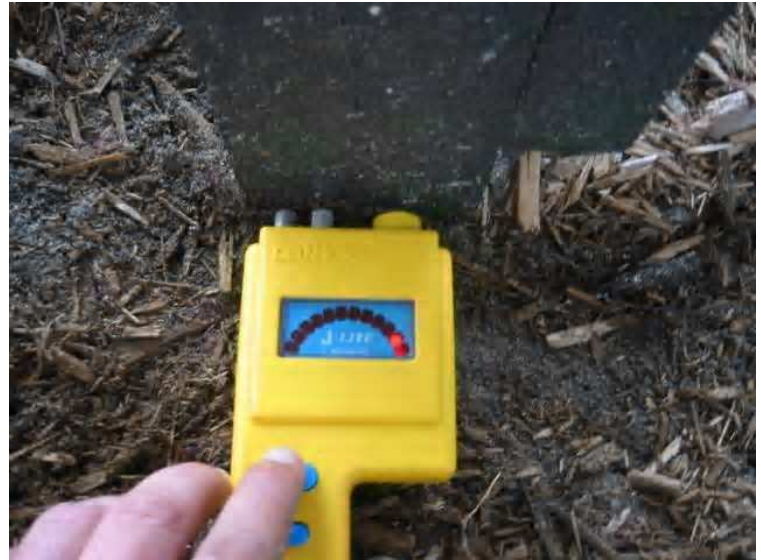
This image shows elevated moisture readings at the base of one of the support columns supporting the wooden stairs coming off the deck on the south side of building B. [see diagram 1 for location off BD3]

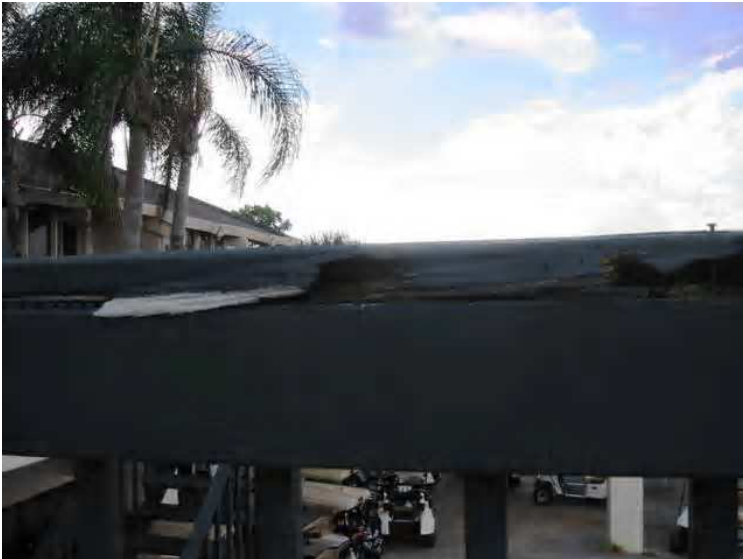
Handrail on east side of deck [BD4 see diagram 1] this handrail is typical of all inspected on the property as it has been damaged by either rot or termite activity, we recommend repairs or replacement as needed.

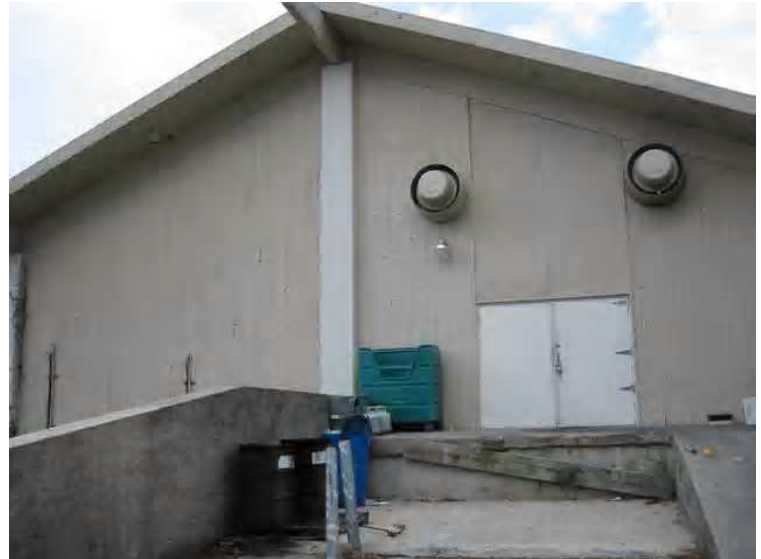
Building B. 2nd floor loading dock, the siding in this area is rotten due to moisture intrusion in the attic space from improper flashing and caulking of the siding materials. We recommend further evaluation of the sill plate, as it could not be viewed at the time of inspection.

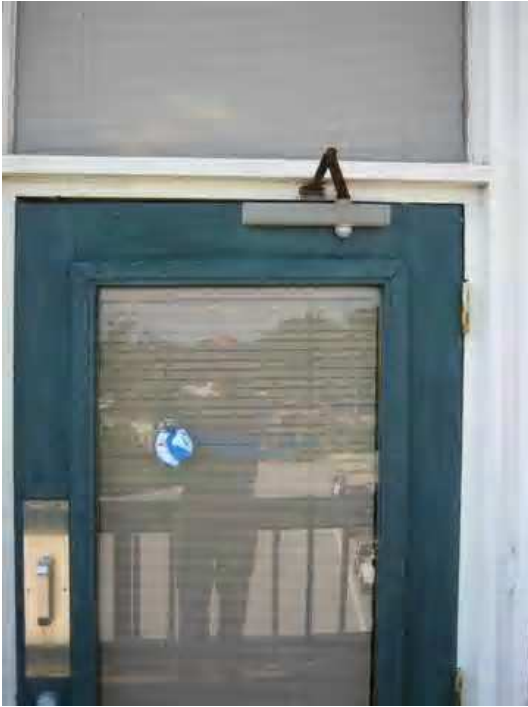
This door leads from the offices in Building A to the exterior deck [AD1 on diagram 1] there is evidence of moisture intrusion into the door framing which forced the door & jamb out of plumb.

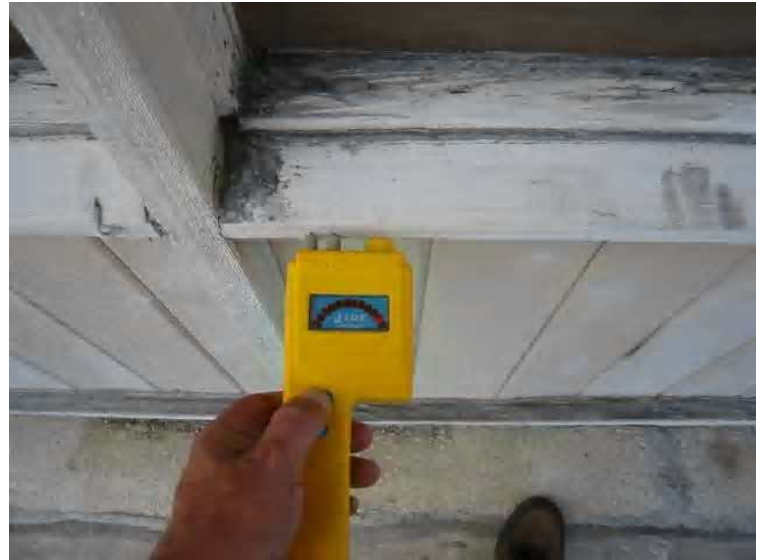
2nd floor office windows as seen from deck [AD1] elevated moisture readings only confirm the visual evidence of rot in the window frame, this is typical of the window elements on both buildings.

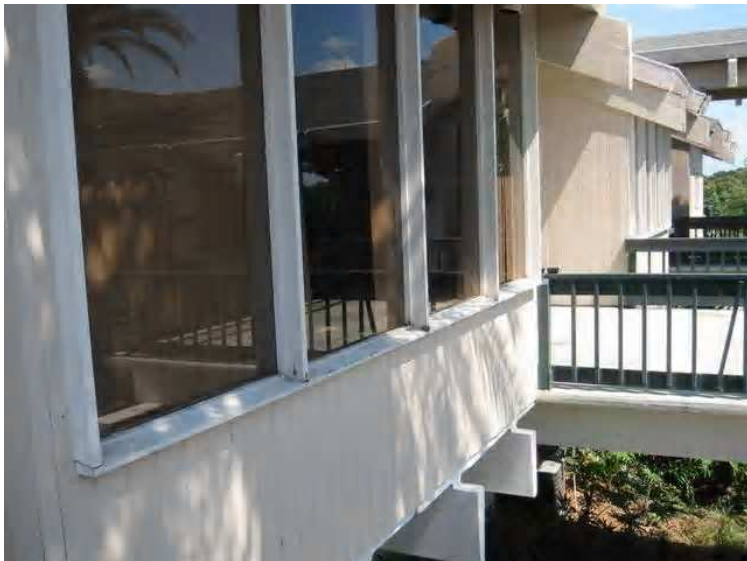
This image depicts significant rot and moisture damage to a window on the south side of building B. As previously mentioned we recommend further evaluation of all window frames on the structure.

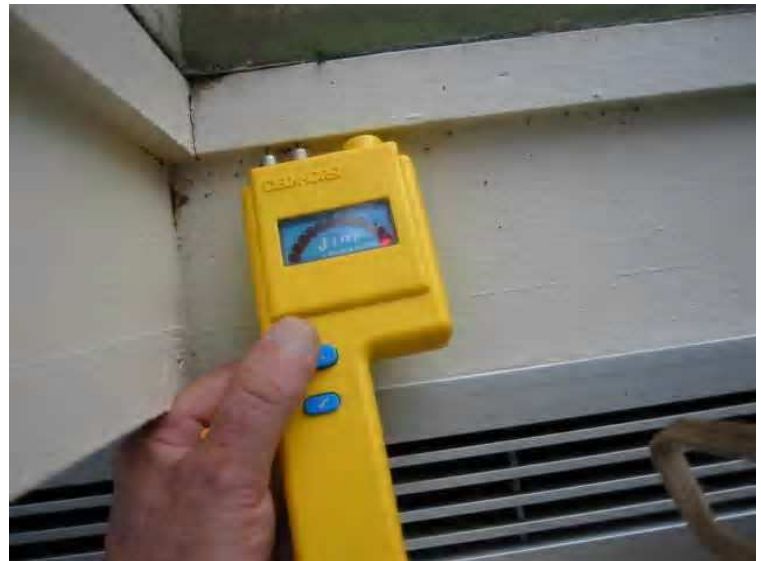
Picture showing elevated moisture readings on an interior frame in the 2nd floor members dining room in building A. this frame is showing moisture in excess of 30%.

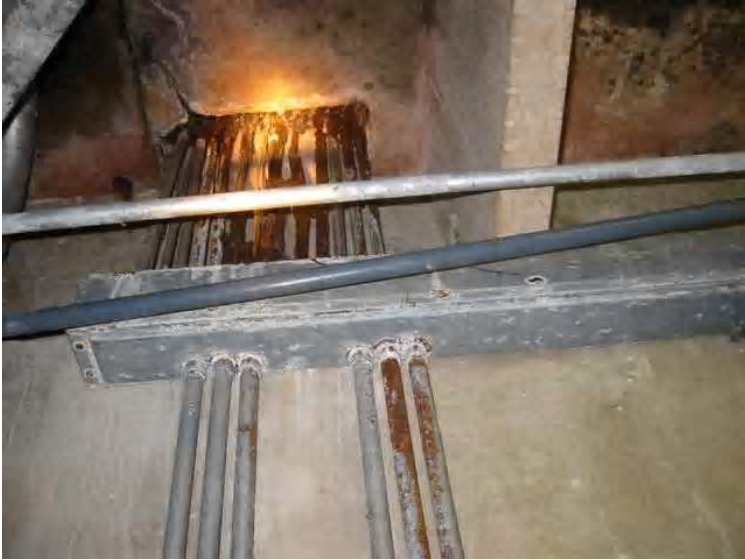
The 2nd floor refrigeration equipment was installed directly over the main electric closet; over time condensation leaking down over the equipment has rusted the riser conduits coming from this closet, see full report.

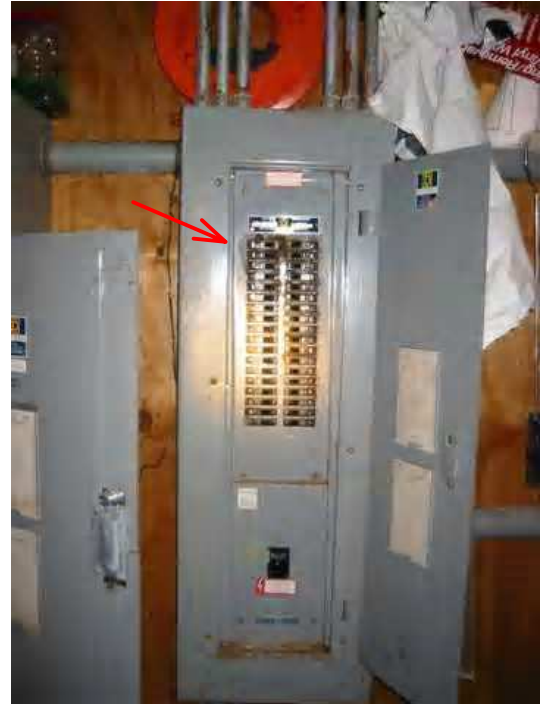
This panelboard has suffered extensive moisture intrusion damage, is rusting out and in a condition of eminent failure. A licensed electrician to correct this condition by replacing this equipment.

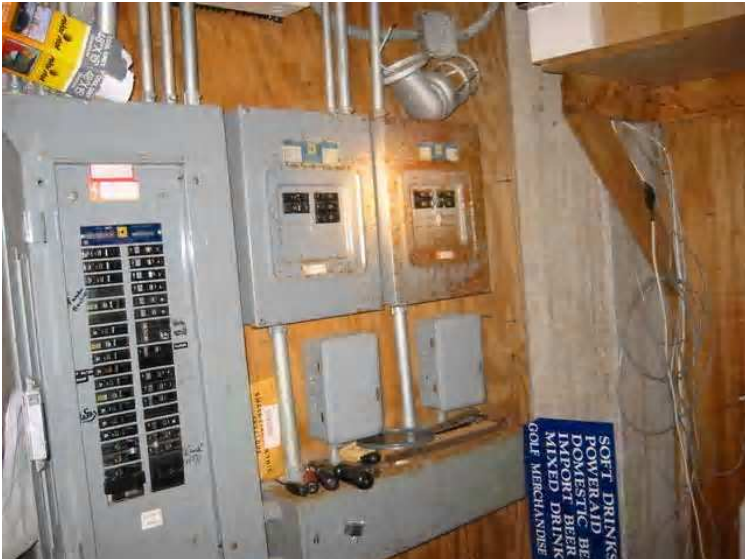
Other electrical equipment that has been damaged by excessive moisture intrusion. Careful consideration should be given to either relocating the electric closet or the walk-in coolers.

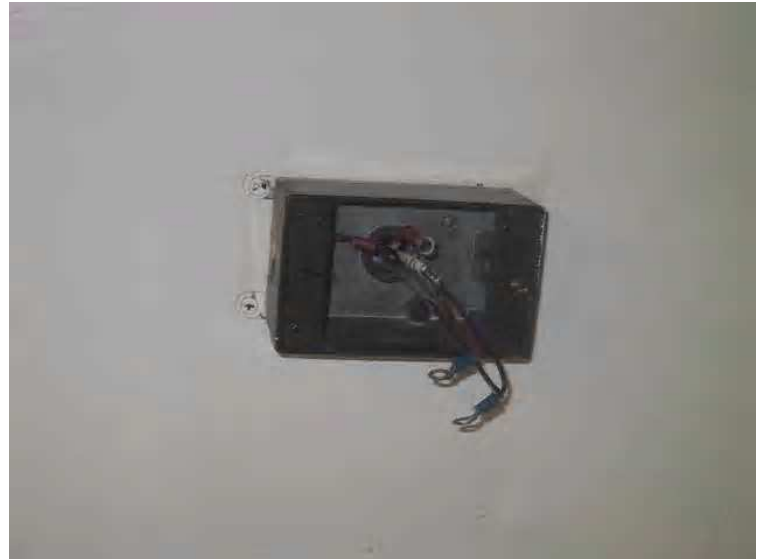
Typical open junction box, one of many that needs attention by a licensed electrician

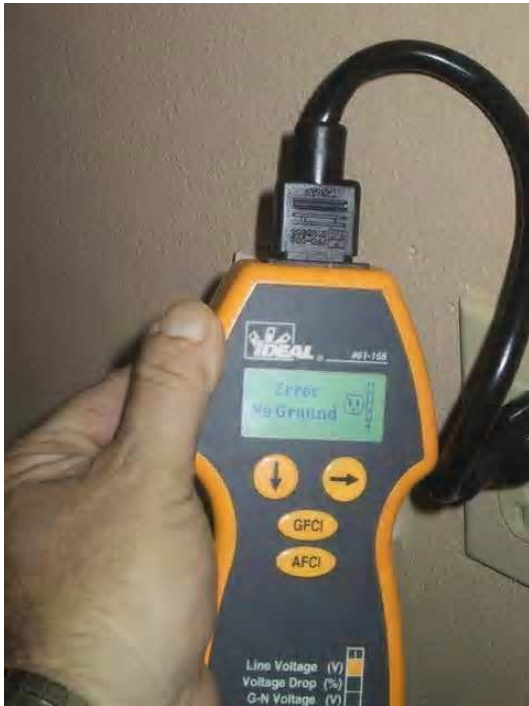
Typical non-grounded receptacle. This condition is most likely related to the damaged conduits in the electrical riser system, further evaluation by a licensed electrician required.

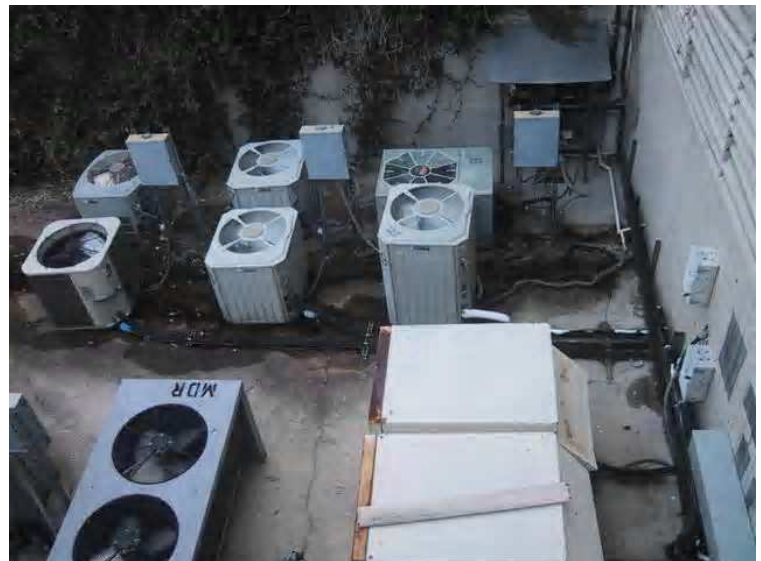
HVAC Condenser's - Split-system A/C condenser units in various stages of deferred maintenance. Note: leaking condensation, frozen refrigerant lines, mold like substances.

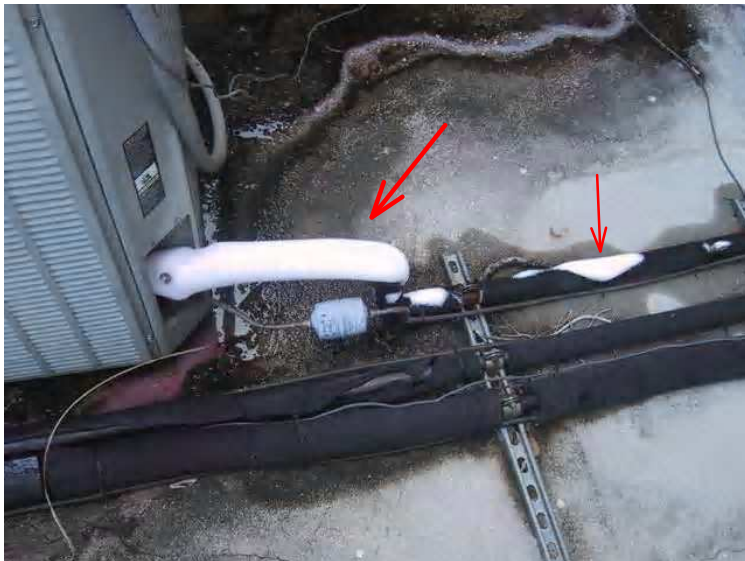
Split-system A/C condenser units showing frozen refrigerant lines this is usually a sign of low refrigerant in the system.

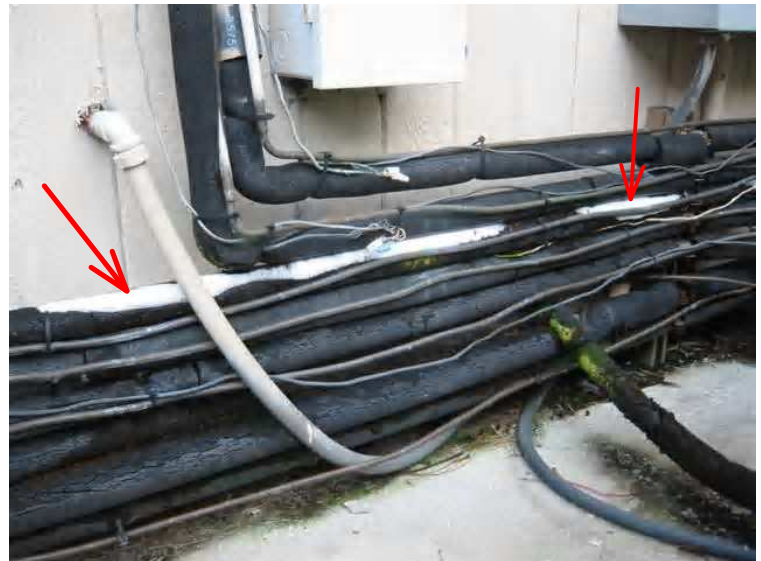
Split-system A/C condenser units showing damaged and frozen refrigerant lines this is usually a sign of low refrigerant in the system.

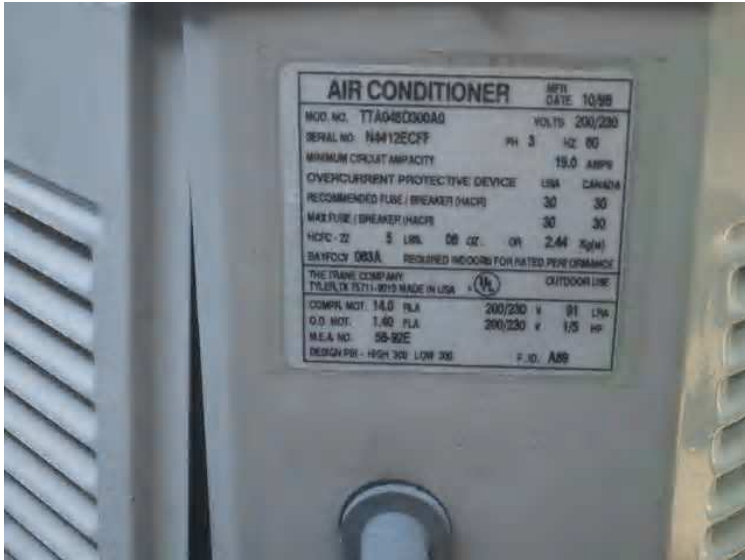
Typical AC Compressor manufacturers plate: The compressors have an average age of 8 years and an average cooling capacity of 4-tons.

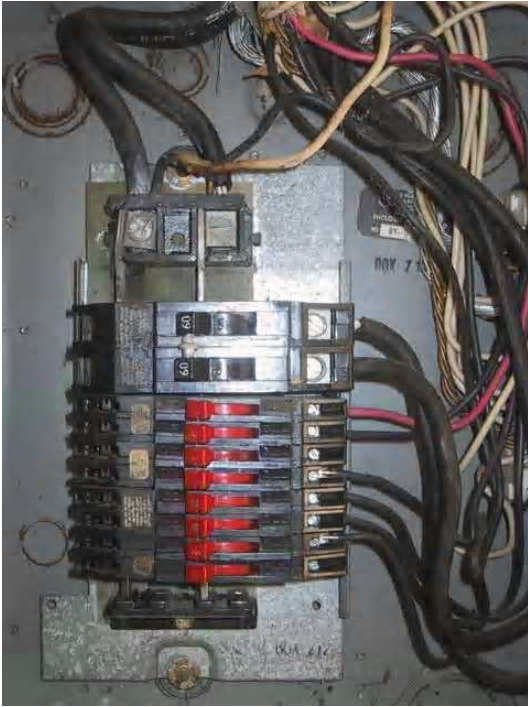
Zinsco brand panel and is cause for concern. We consider this panel to be potentially hazardous and strongly recommend that it be replaced at the earliest opportunity.

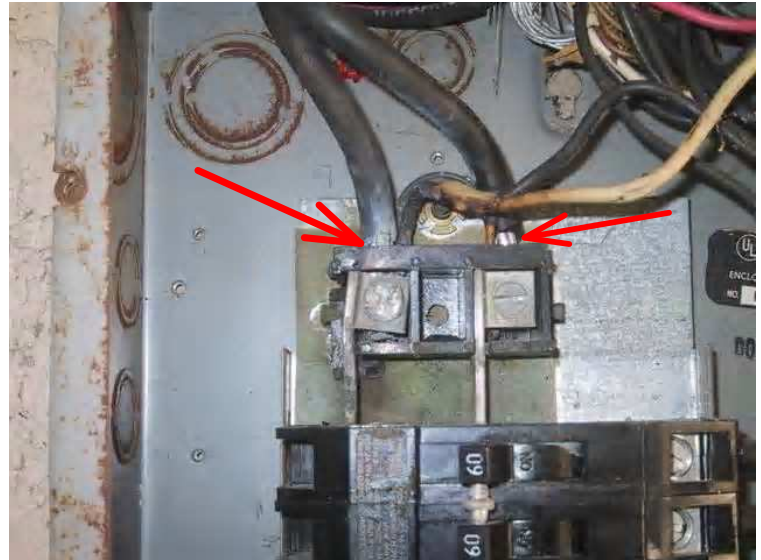
The main lug is double tapped which is an electrical code violation and shows signs of overheating. This condition is a safety hazard and should be corrected by a licensed electrical contractor ASAP before anyone is hurt.

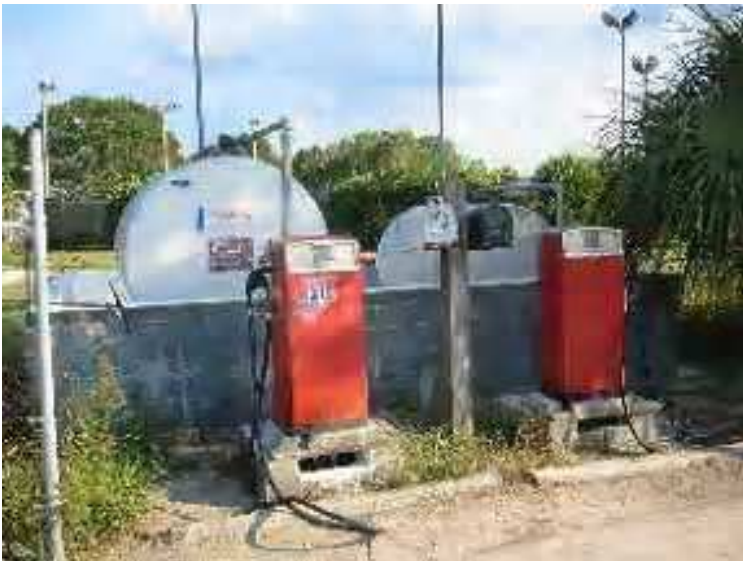
Maintenance Buildings - Oil and fuel storage tanks should be professionally evaluated and a current fire certificate should be obtained from the seller, see full report.

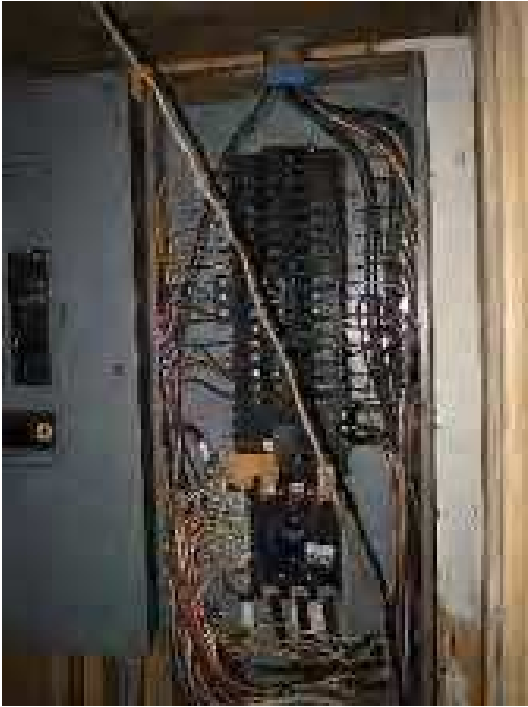
Maintenance Buildings - The electrical service in this building is in an unsafe condition, see full report.

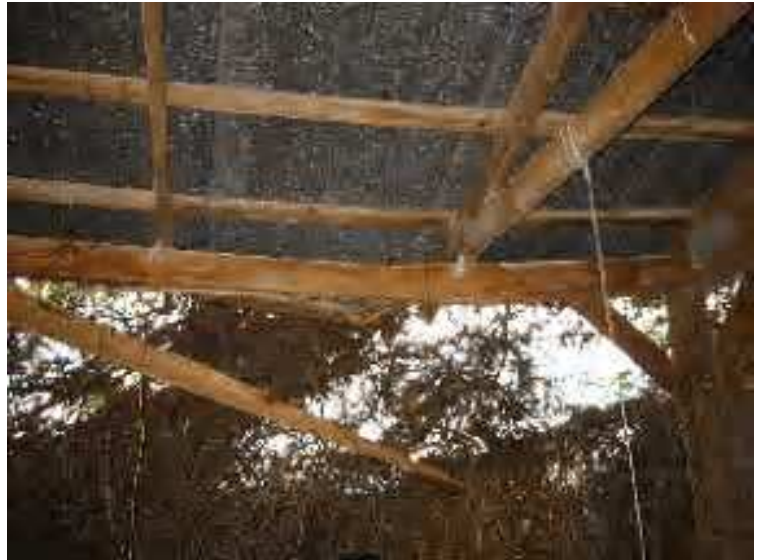
Maintenance Buildings - The cart storage barn roof is in particularly poor shape possibly from previous storm damage, see full report.

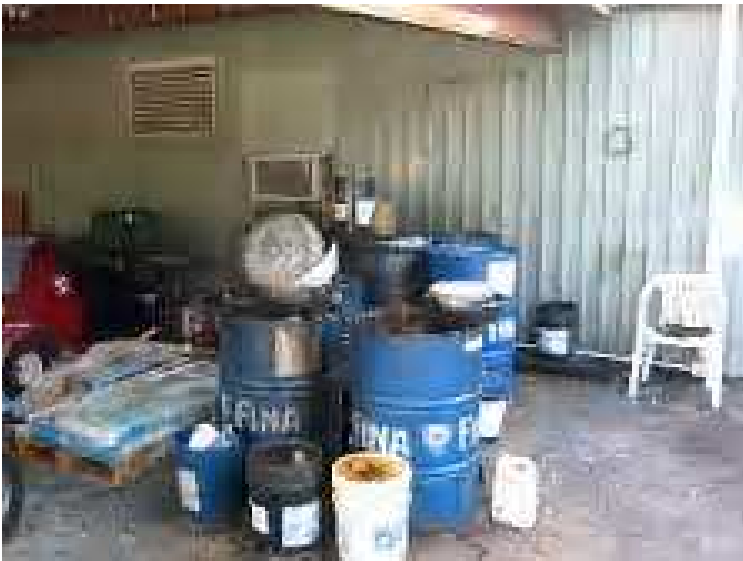
Maintenance Buildings - During the inspection we noted a large quantity of used oils and other hazardous materials stored on-site, see full report.

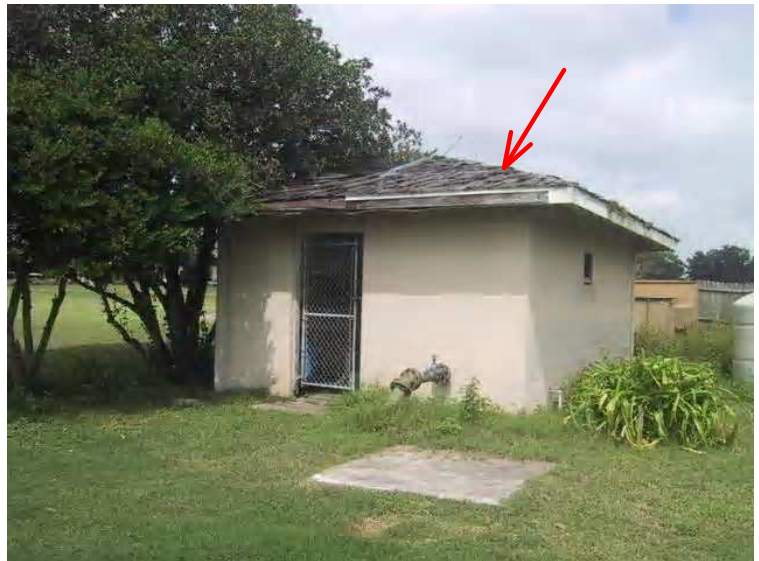
Pump House - Note the roof which is in eminent danger of failure and collapse.

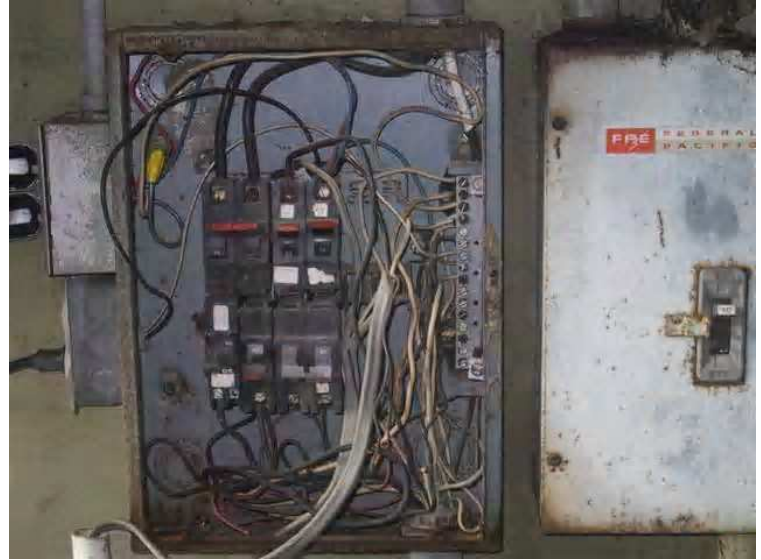
Pump House - The electrical system is designed as NEMA 1 which is indoor only, all electrical equipment has been exposed to the weather over a long period of time and should be abandoned and replaced.
