Inspection Service, LLC

Imported Drywall Survey – 123 Main Street

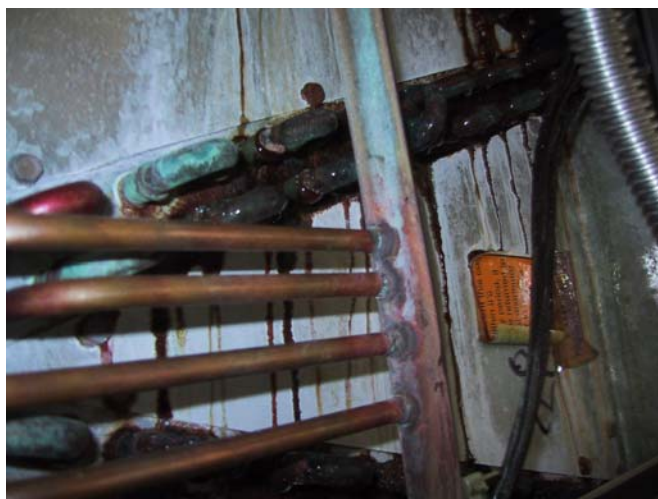
Included for your records is a photo of your cooling coil on the day of inspection which looks normal.
